**AN ANALYTICAL MODEL FOR PREDICTING
CROSS-COUNTRY VEHICLE PERFORMANCE
APPENDIX D: PERFORMANCE OF AMPHIBIOUS VEHICLES IN
THE WATER-LAND INTERFACE (HYDROLOGIC GEO/METRY)**

February 1970

Conducted by U. S. Army Engineer Waterways Experiment Station, Vicksburg, Mississippi 39180

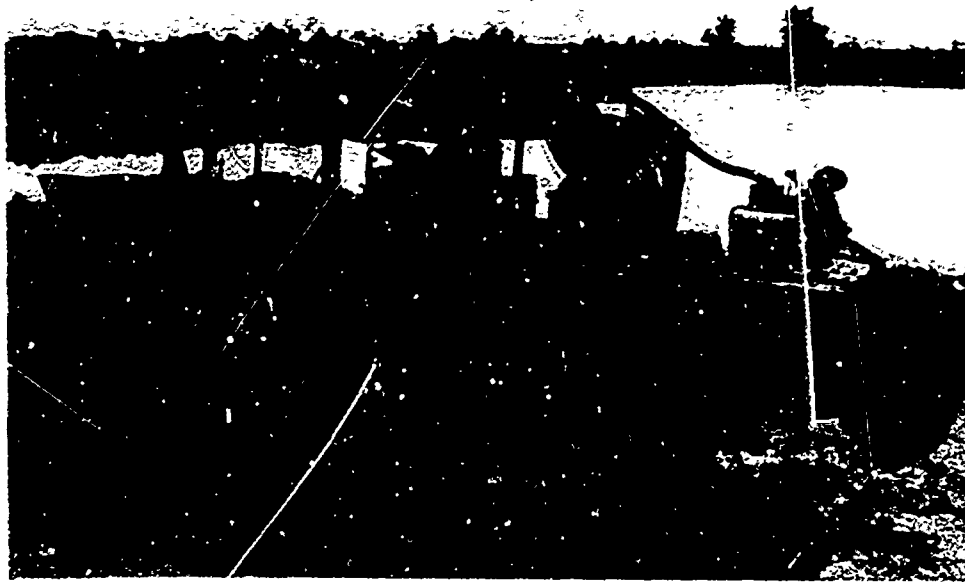
Fig. D5. Amphibious cargo carrier, M29C

9. The M29C is a low silhouette, tracked vehicle (fig. D5) designed to transport personnel or light cargo on land and water. Watertight compartments in bow and stern add to the buoyancy of the vehicle. The stern

compartment is fitted with rudders to steer the vehicle in amphibious operations. The vehicle is powered with a liquid-cooled six-cylinder engine located in the right front of the hull. Power is transmitted from the engine to the rear axle by a power train consisting of a single plate clutch, conventional transmission, and a two-speed axle unit with combined

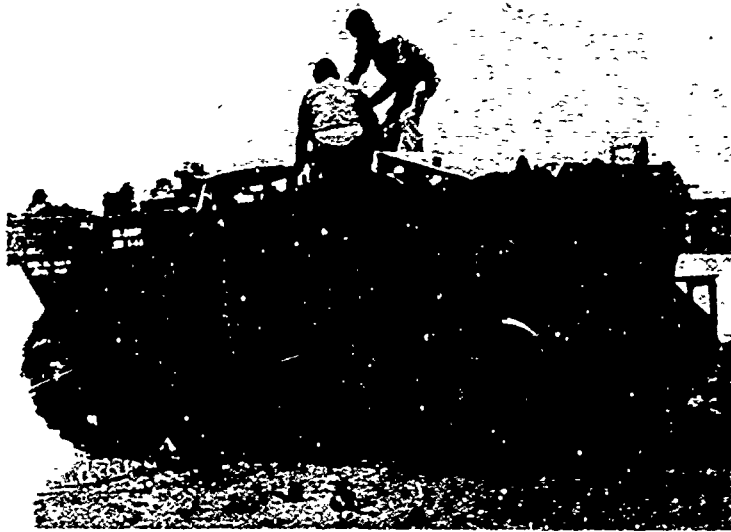
Fig. D7. Armored personnel carrier M113

10. The M113 armored personnel carrier is a tracked vehicle (fig. D7) designed to transport 12 troops, plus driver. It is capable of amphibious operation across lakes and streams, of extended cross-country travel over rough terrain, and of high-speed operation on improved roads and highways. Power is supplied by a 209-hp Chrysler Model 75 M engine coupled through a transfer case to an Allison TX200-2A transmission (hydraulic) and an FMC DS200 controlled dif-

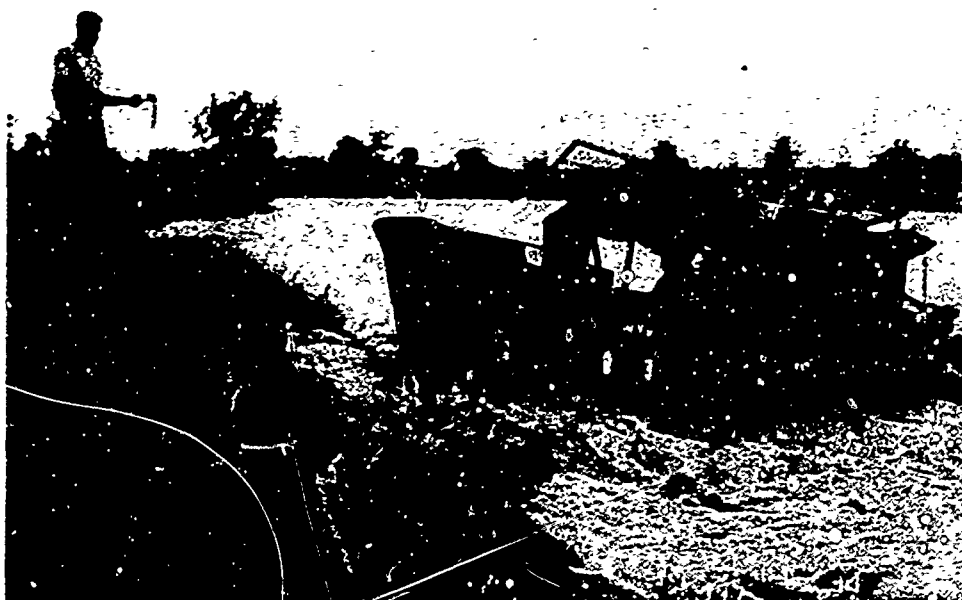
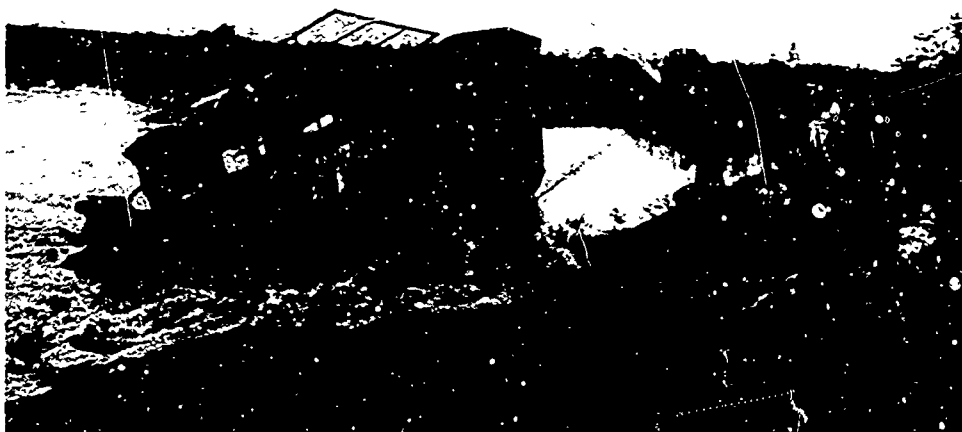
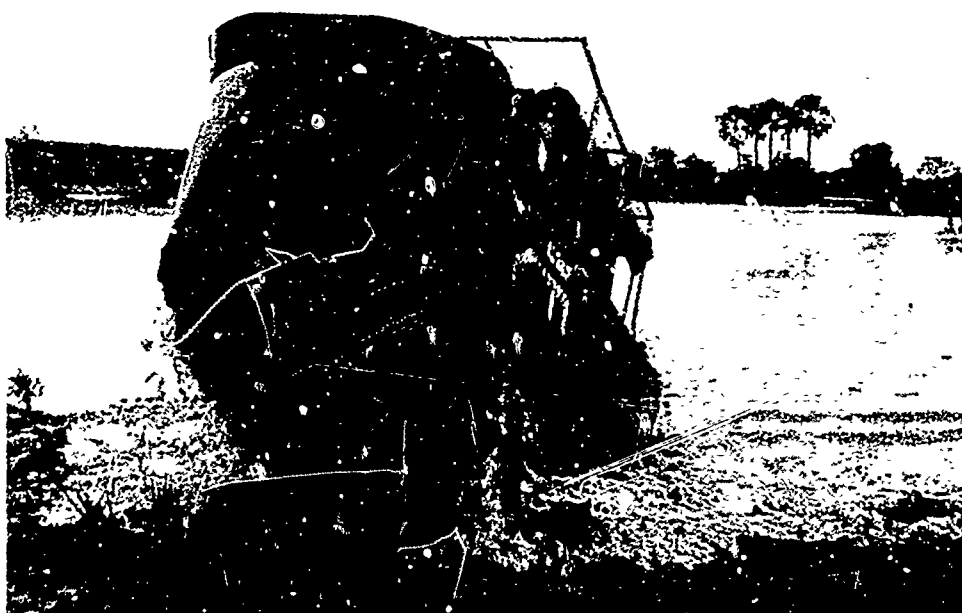
Fig. D13. Three M29C tests in progress near Khon Kaen

a. M29C immobilized in the water-land interface at test site 5-H-8, Thailand

b. M29C negotiating the water-land interface at test site 5-H-3 Thailand

c. M29C negotiating the water-land interface at test site 5-H-4, Thailand

30. Thailand tests. The test results for the nine water-land interface tests conducted in Thailand wherein the vehicle climbed various slopes while exiting water bodies are summarized in table D2. Fig. D13 shows three tests in progress. A plot of the tangent of the slope angle versus the average 0- to 6-in. cone index for these tests is shown in fig. b, plate D2. The drawbar pull-soil strength curve from fig. a, plate D2, has been drawn on fig. b, plate D2, to form a line of separation between the immobilizations and the nonimmobilizations. Two tests, 134 and 136, in which immobilization did not occur fall above the line of separation where it would be expected that the combination of slope and soil strength would immobilize the vehicle. Referring to table D2, it may be seen that in test 134, the recorded slip for the test was 44.6 percent, indicating that the vehicle was proceeding with considerable difficulty. It may be further seen from table D2 that the 44.6 percent slip for test 134 was the highest slip recorded for any M29C tests, barring the immobilizations, of course. Again referring to table D2, it may be noted that the vehicle was partially floating when it crossed the maximum slope in test 136; hence, the maximum

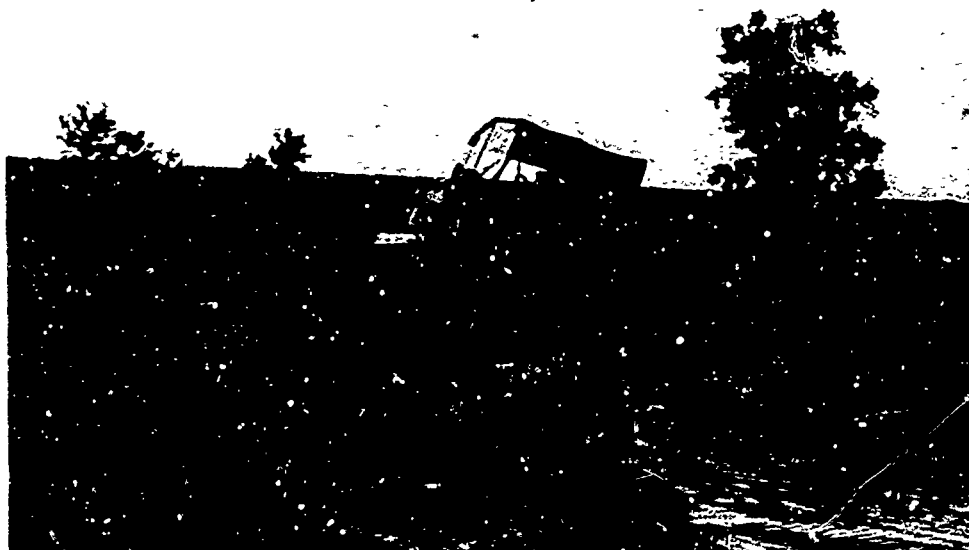
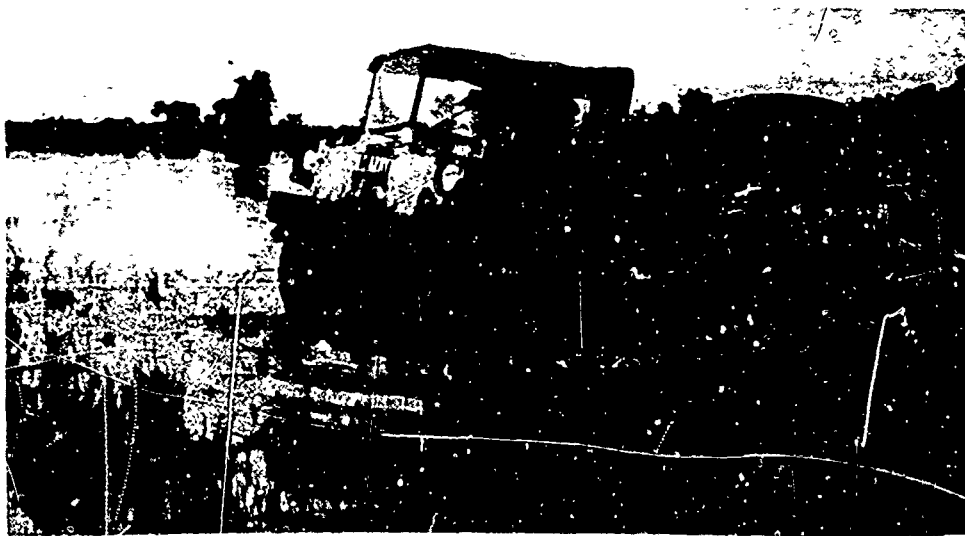
Fig. D15. Two XM561 tests in progress near Khon Kaen

a. XM561 immobilized in water-land interface at site 5-H-4

b. XM561 negotiating the water-land interface at site 5-H-6

36. From observations made during the XM561 tests it was noted that articulation is an important factor in making the transition from water to land. The articulation joint allows the front unit of the XM561 to conform to the shape of the interface immediately upon contact with the bank, thus putting four wheels in contact with the bank surface at the most critical time during the transition phase. It was observed during the tests that at least some kinetic energy obtained from water speed was frequently necessary to start the XM561 up the bank. Fig. D15 shows the XM561 operating in the water-land interface.
